Monitoring Data Record

Project Title: R-0210A (Site 10) COE Action ID: 1993-0-0570
 Stream Name: Unnamed tributary to the Little River DWQ Number: 010404
 City, County and other Location Information: US 1 (Vass Bypass) in Moore County
(Sta. 51+70 to 52+20)
 Date Construction Completed: July 2003 Monitoring Year: (1) of 5
 Ecoregion: _____ 8 digit HUC unit: 03030004
 USGS Quad Name and Coordinates: _____

Year 1 – June 2005

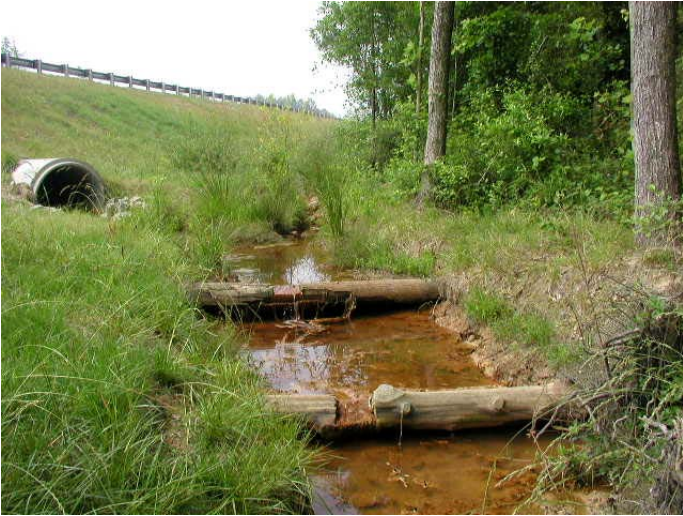
Photo 1

The stream is stabilized for the 1st year of monitoring. The log vane structure noted in photo 1 is set too high and is holding the water flow onsite. This log vane will be reset to the correct elevation of the structure.

Date Inspected	Station Number	Station Number	Station Number	Station Number	Station Number
Structure Type	51 + 80 @ log vane				
Is water piping through or around structure?					
Head cut or down cut present?					
Bank or scour erosion present?					
Other problems noted?	Water is ponding behind log vane
